## SCU Wear Replacement Guide MY23

Serial Number #SC0300 - Present

# SCU Wear Replacement Guide

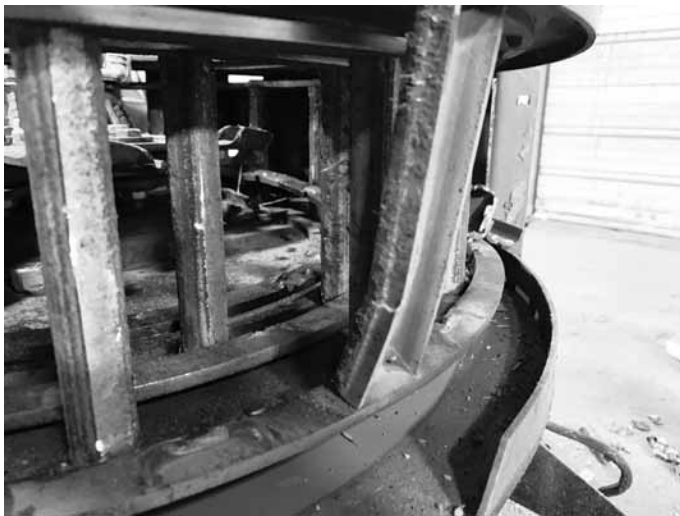
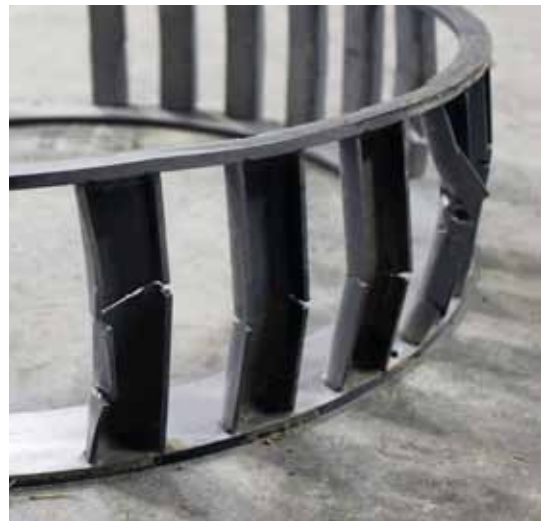
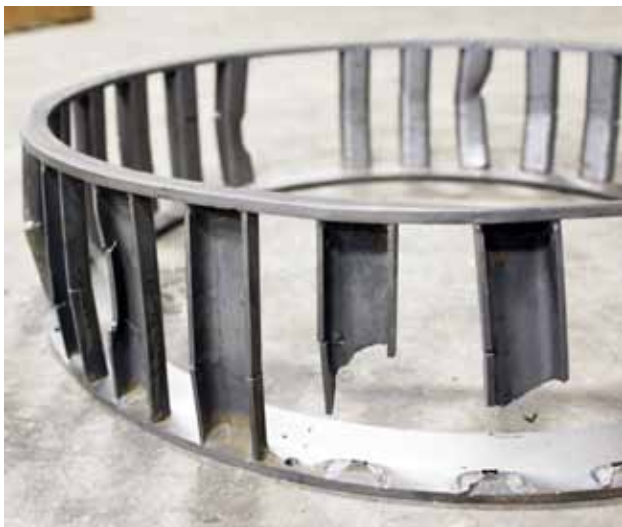
- The rotor and/or stator bars crack, bend or break

- This is a result of a foreign object going through the system

Major Failure

- Replace the rotor or stator with a new unit
- After removal of rotor and stators, check driveline by manually rotating drive and feeling rotation for rough spots - replace bearings as required

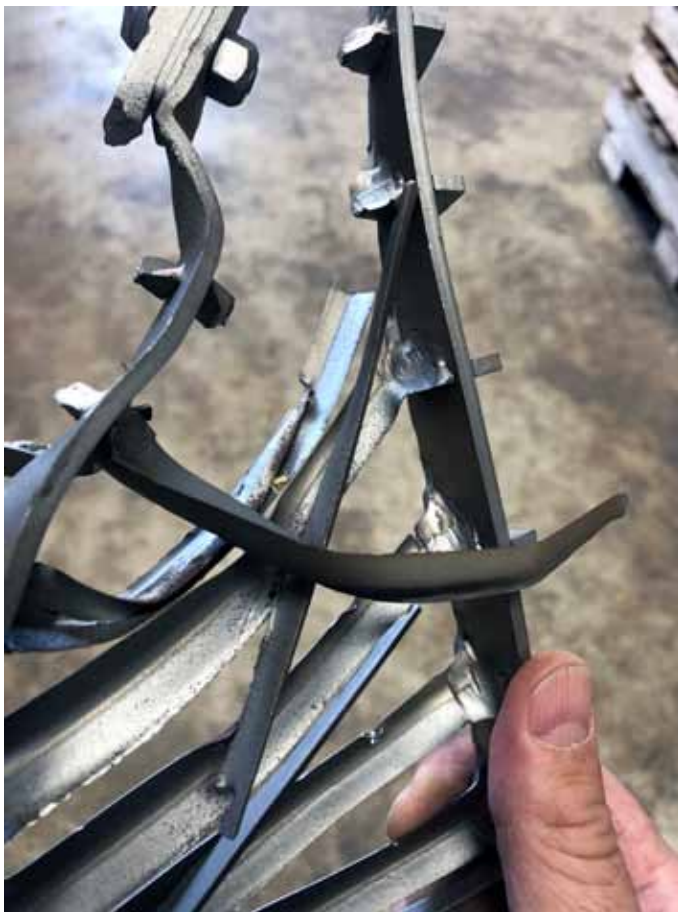
- The rotor and/or stator bars crack, bend or break

- The bars have excessive wear and have lost structural integrity. They may have broken as a result of a minor foreign object going through the system.

Major Failure

- Replace the rotor or stator with a new unit

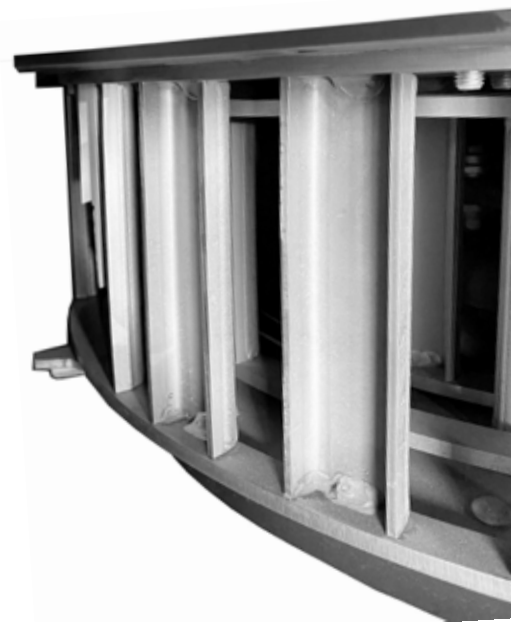
Minor Wear

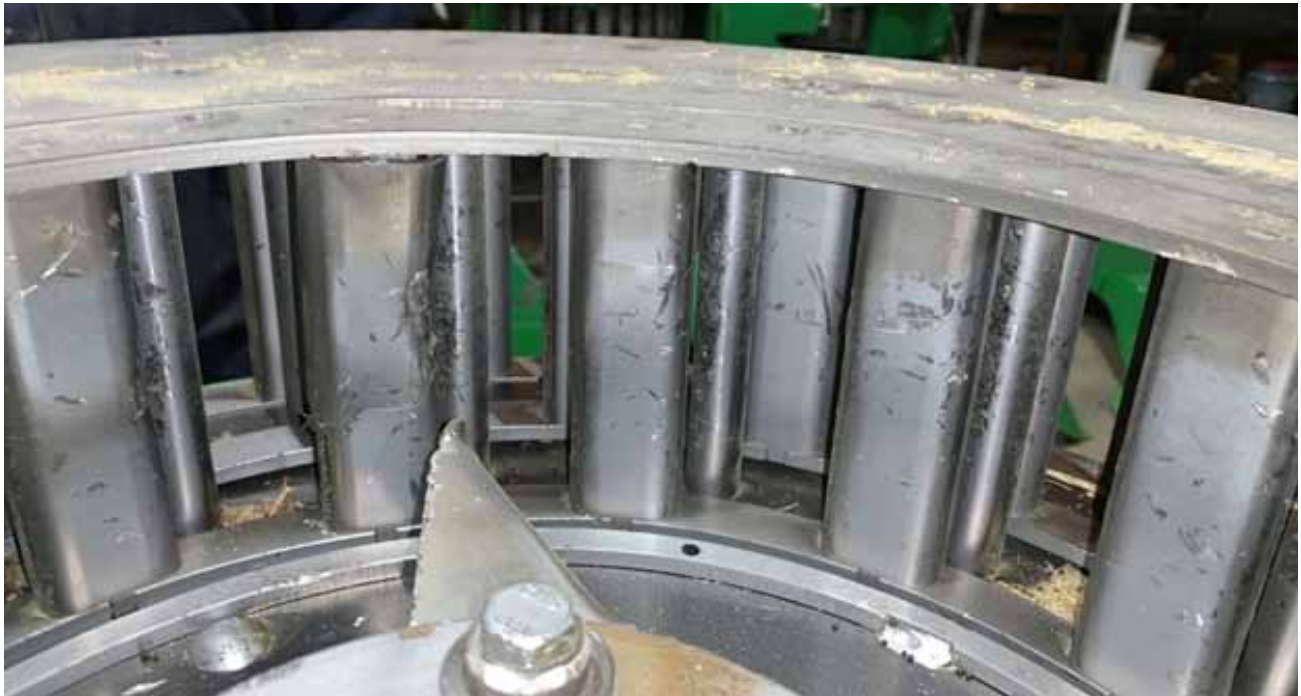
- Blades/bars have nicks

- This is a result of a foreign object going through the system

Major Nicks

- Inspect on a regular basis, if the nick becomes larger and penetrates into the bar far enough to affect structural integrity, replace accordingly.

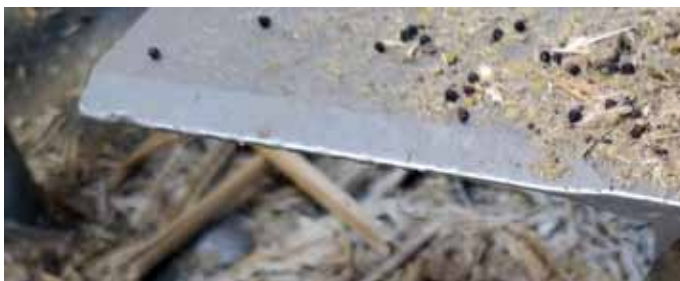
Minor Nicks

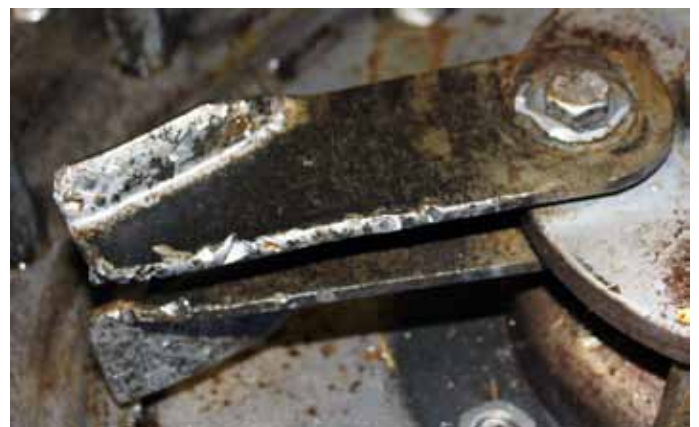
Minor Nicks

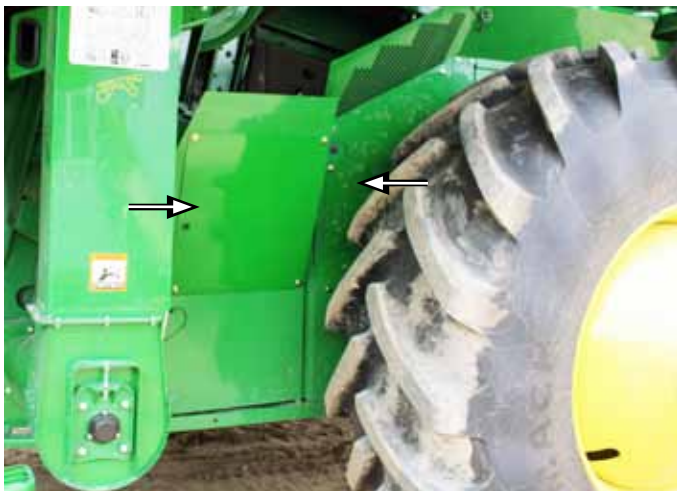
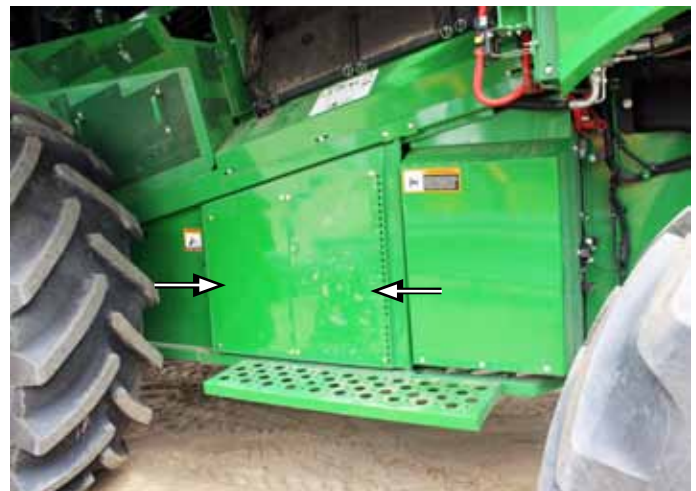
- Wear on mill components is uneven between left and right mills

- Product is fed into SCU unevenly - heavier feed on left or right side
- Sand or soil is being sucked into one side of combine by shoe fan

Inlet Screen Covers

- Adjust return feed to evenly distribute tailings to the shoe
- Adjust combine concaves to more evenly distribute material on the shoe
- Ensure combines shoe fan inlet screens have been covered if near the tires. Parts were included in the John Deere kit - reorder if missing

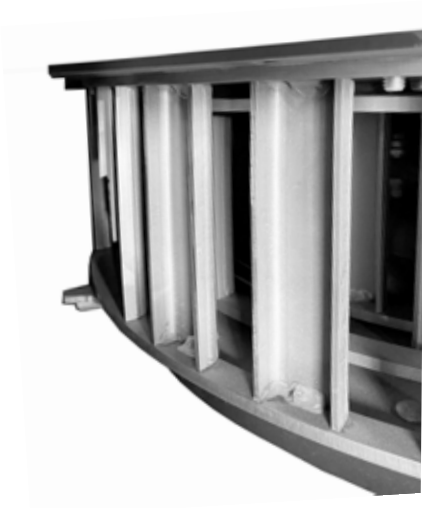
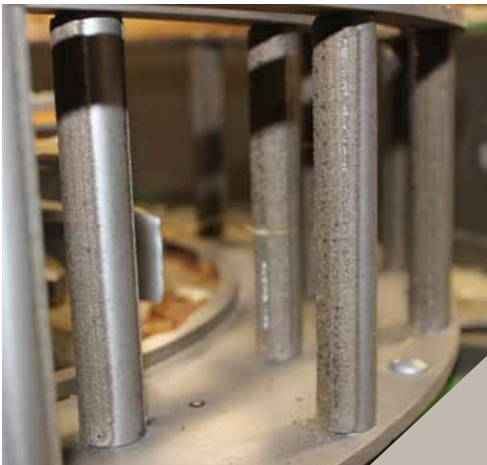
- Components have excessive wear

- Product processed through SCU in a longer time frame without being inspected

Minor Wear

- Replace as soon as hard surfacing has worn through

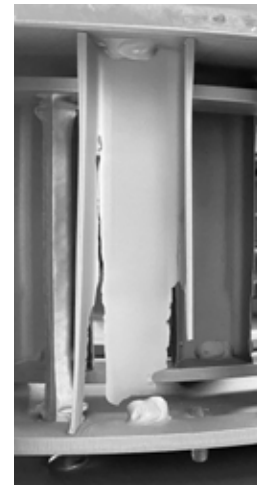
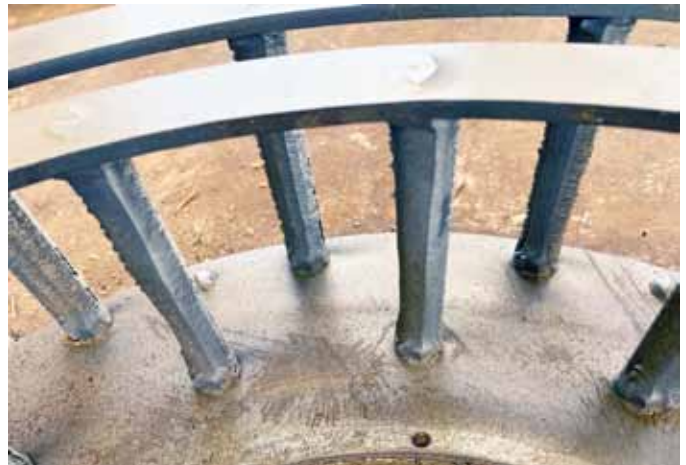
Major Wear

Failure to replace will void all warranty!  
Loss of structural integrity of rotors and or stator bars will result in catastrophic failure

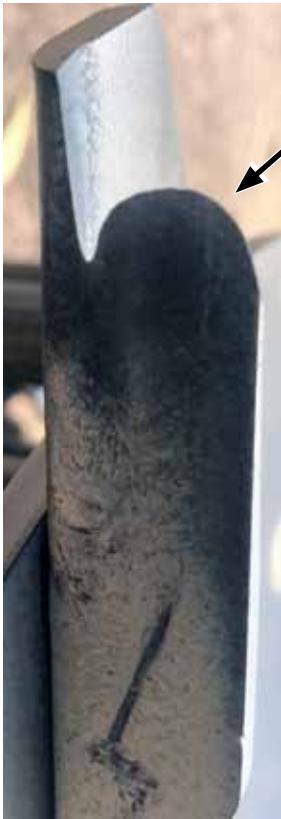
- Fan blades have excessive wear on corners and tips of blades

- Product processed through SCU in a longer time frame without being inspected

Major Wear

- Replace fan blades
- If the wear is minor, replace at end of season in preparation for the next season
- Failure to replace fan blades with major wear will result in reduced performance and plugging as suction into the Seed Control Unit and velocity exiting the unit is dramatically reduced

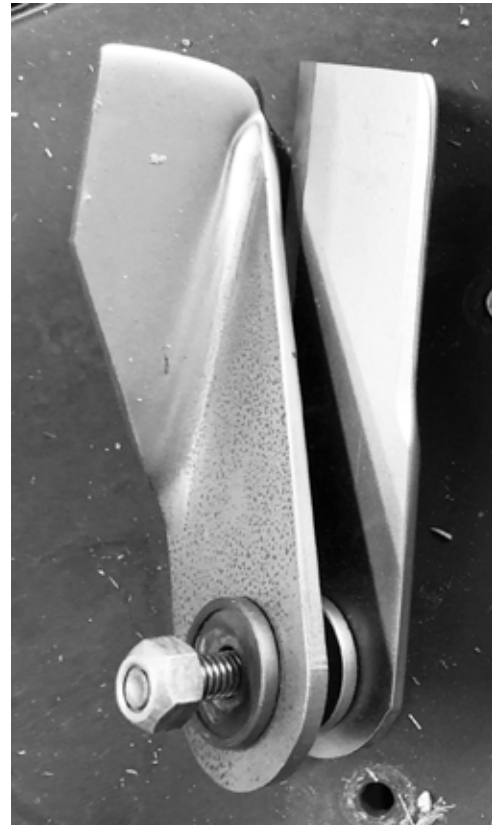
Minor Wear

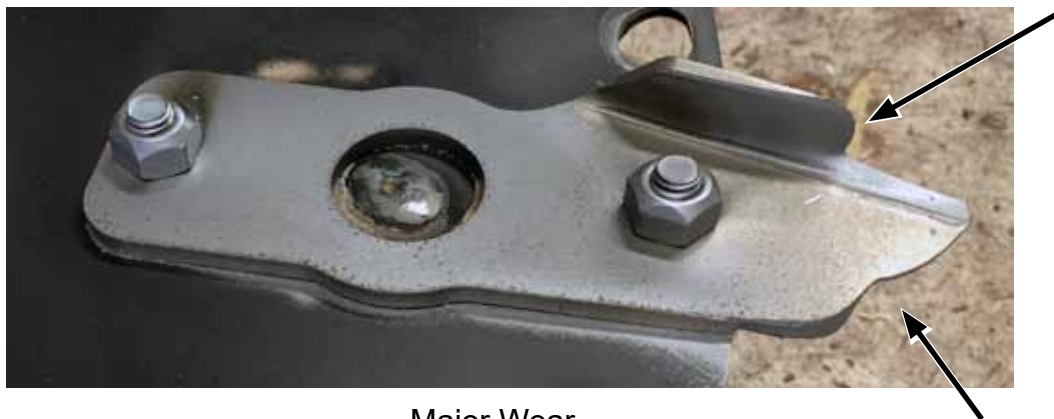
- Scraper blades have excessive wear on corners

- Product processed through SCU in a longer time frame without being inspected

Major Wear

- Replace scraper blades
- If the wear is minor, replace at end of season in preparation for the next season

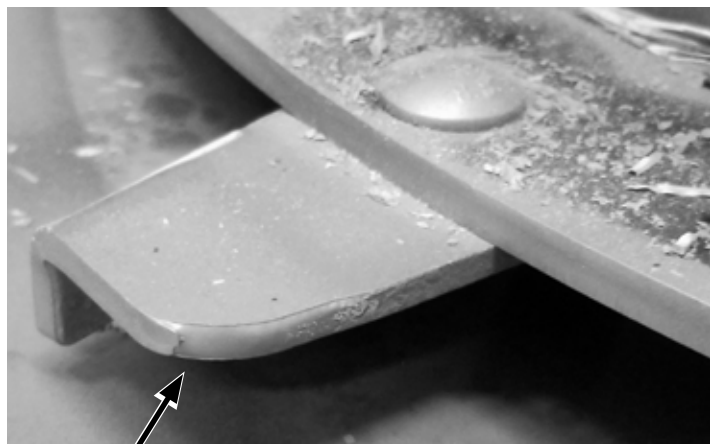
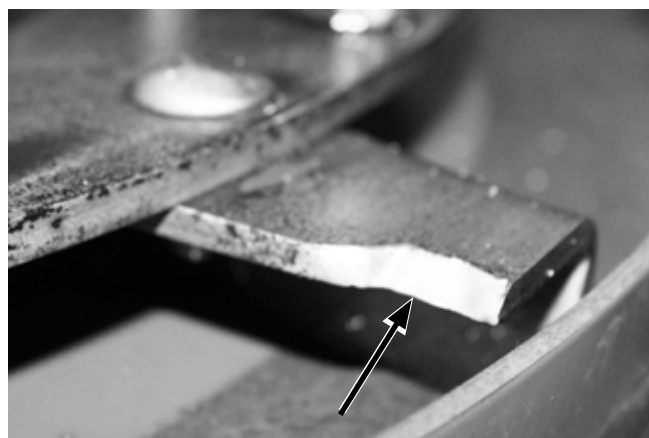
Minor Wear

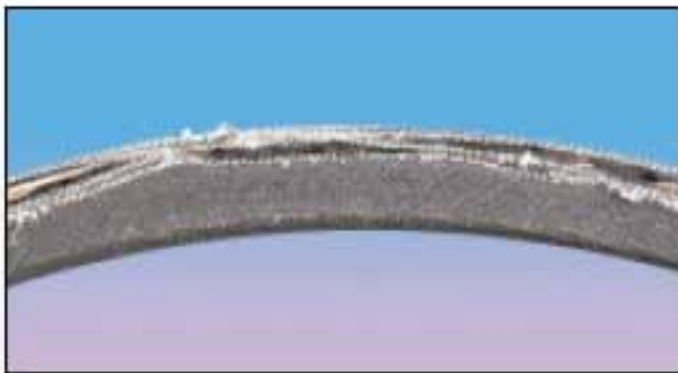
Rapid Sidewall Wear

- Worn or damaged sheaves
- Sheaves misaligned
- Insufficient tension
- Improper storage
- Excessive heat
- Use of belt dressing
- Abrasive environment

- Replace broken belt
- Set belt tension to indicator setting, check tension regularly for first 2 days
- Check belt tension daily thereafter

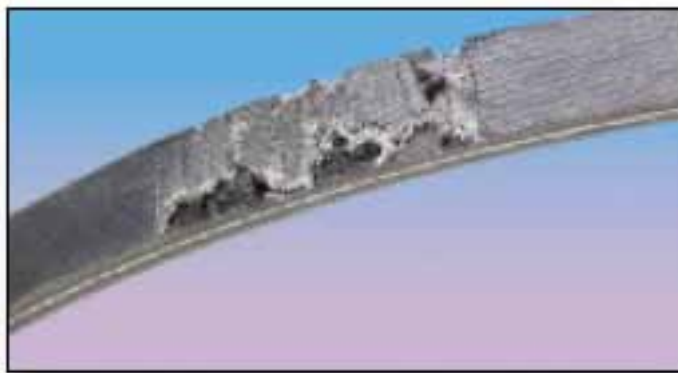
Worn Cover on Back

- Belts pried on
- Worn Idler - has worn backside of idler beyond useful life - replace idler

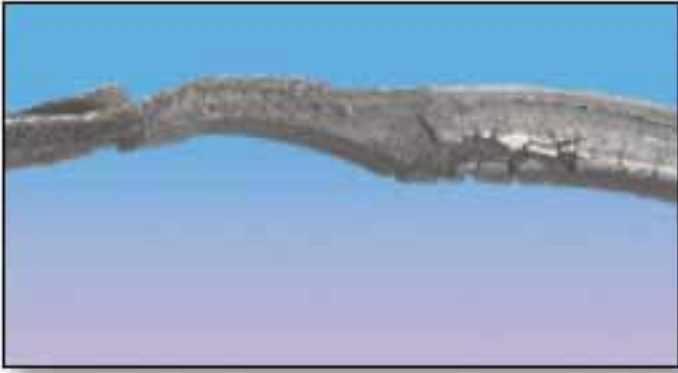
- Causes:
- Worn or damaged sheaves
  - Insufficient tension

Belt Slips, Squeals (Spin Burn)

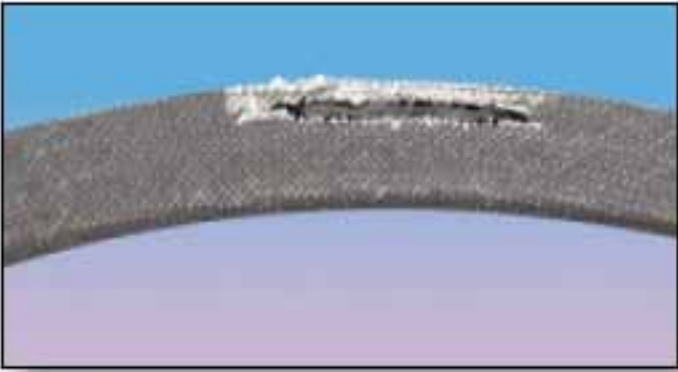
- Causes:
- Belt pried on
  - Foreign objects in sheave grooves

Belt Cover Split

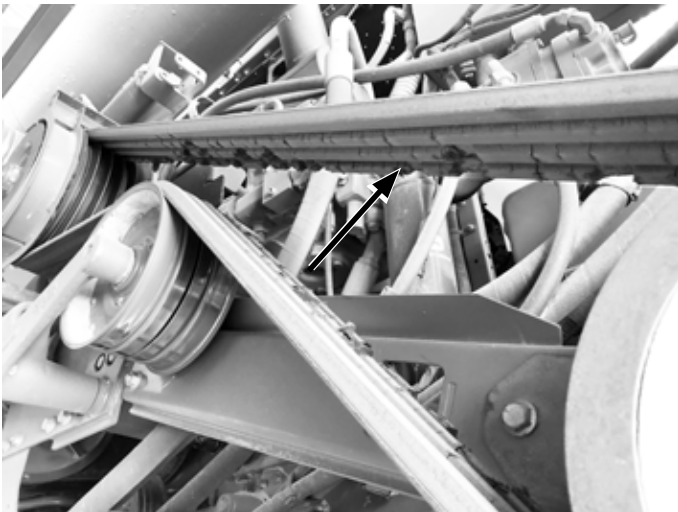
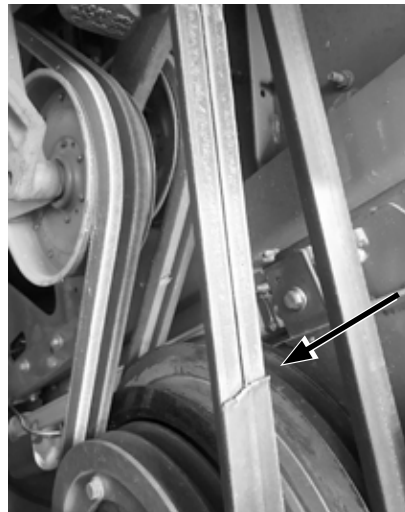
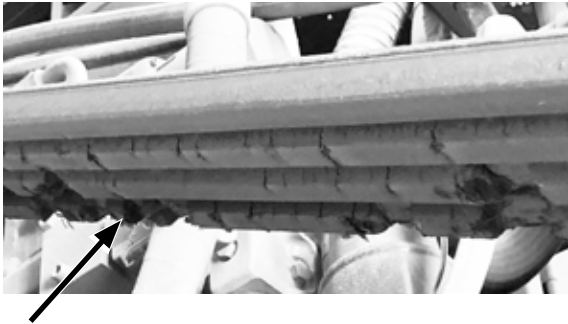
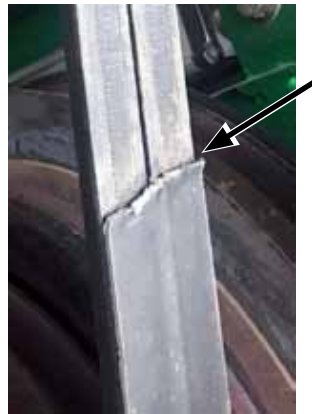
- V Belt surface has cracks

- Belt tension is/was not set correctly - belt has slipped and overheated
- Belt is old and dried out

Major Wear

- Replace belt with a new belt
- Set belt tension to indicator setting

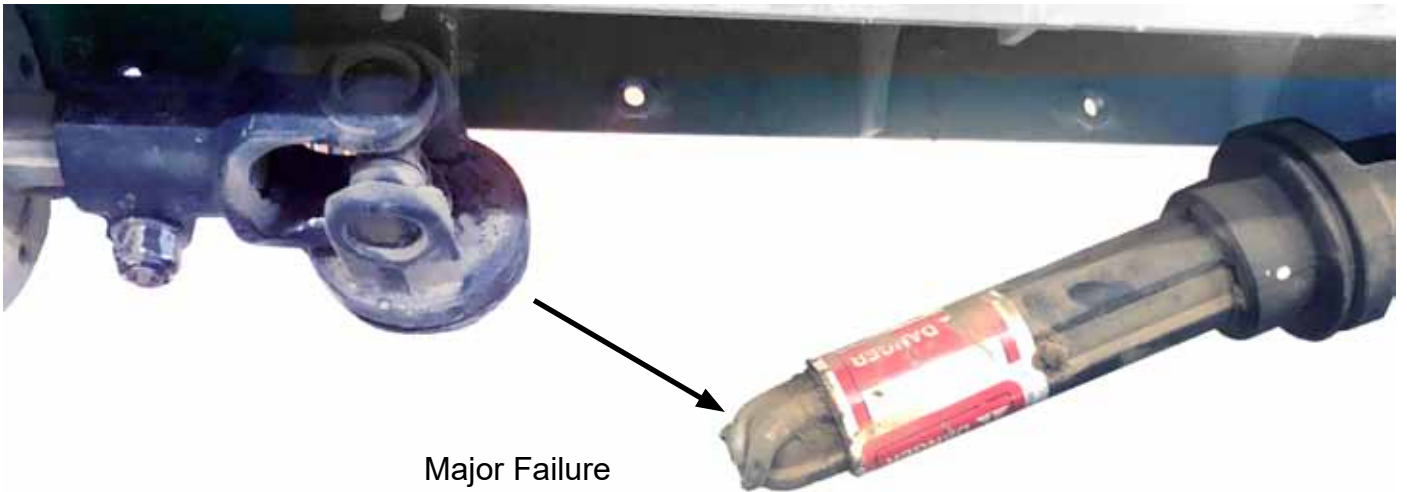
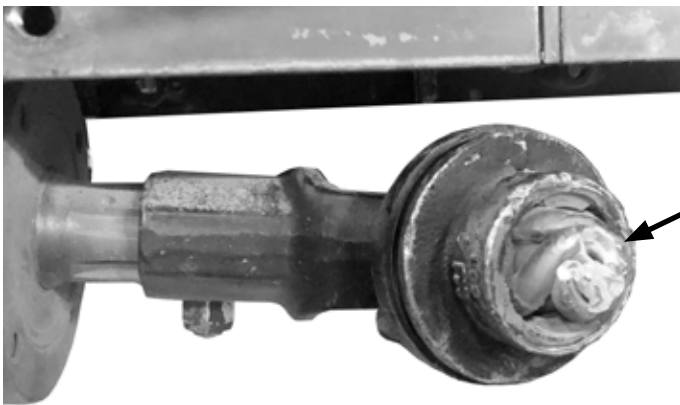
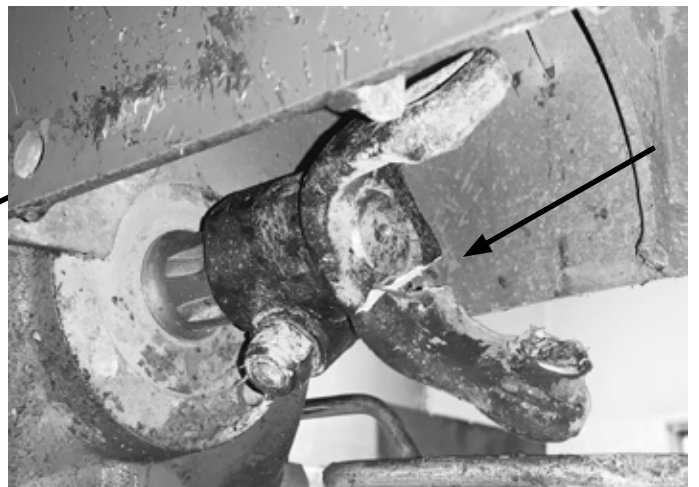
- Driveline is twisted or broken

- Foreign object/catastrophic damage to one mill lead to sudden stoppage

- Remove damaged parts to mill
- Remove damaged driveline
- Rotate driveline and gearboxes manually
- Check for rough spots on bearing and gear teeth
- Replace parts as required

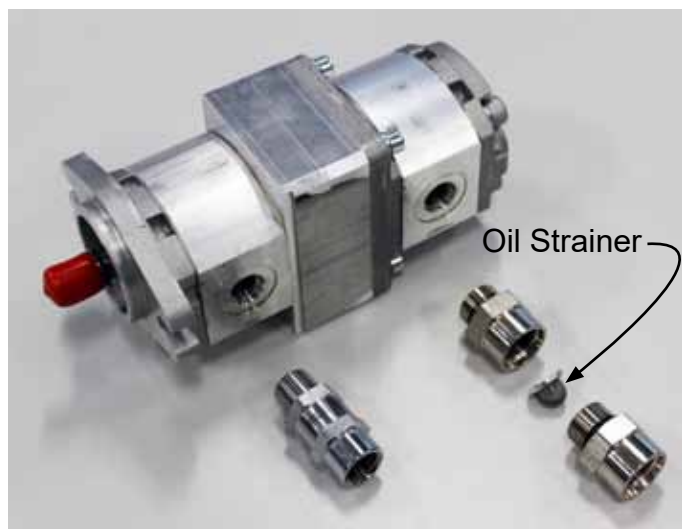
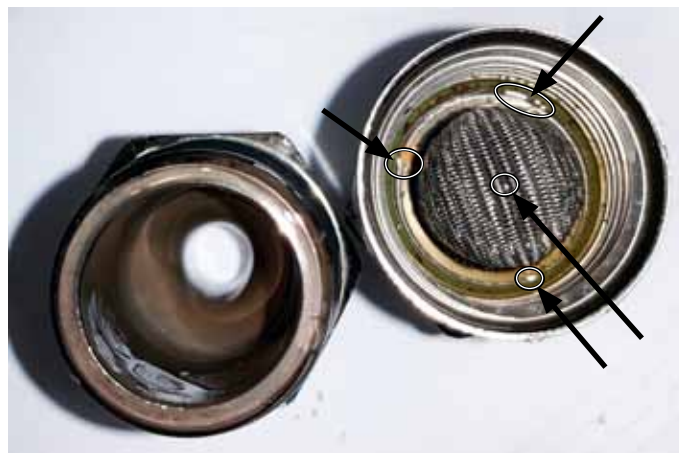
- Oil pump no longer circulates oil

- Leak in system causing oil cavitation and destroys pump
- Oil temperature overheated and ruined seals
- Pump runs dry and overheats
- Pump oil strainers are plugged causing oil cavitation
- Oil was not changed initially after breakdown - 50 Hours, suction strainers not cleaned

Filings in Oil Strainer

- Replace/repair pump
- Replace leaking oil lines
- Determine problem of overheating
  - Clean coolers
  - Clean oil strainers/pump inlet

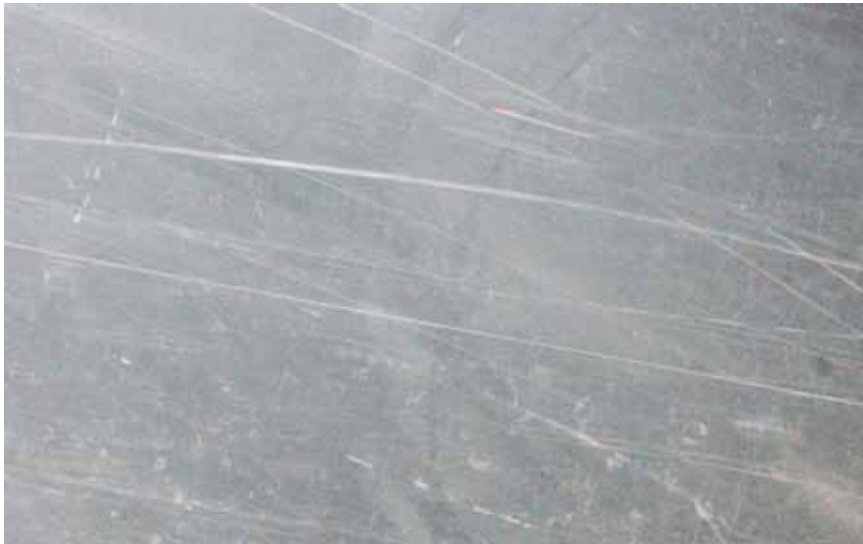
- Surfaces scratched / finish altered

- Surface scratched from adjacent parts
- Surface altered from wet residue

Wear

- Space out adjacent parts from SCU
- Tighten adjacent parts
- Clean unit daily

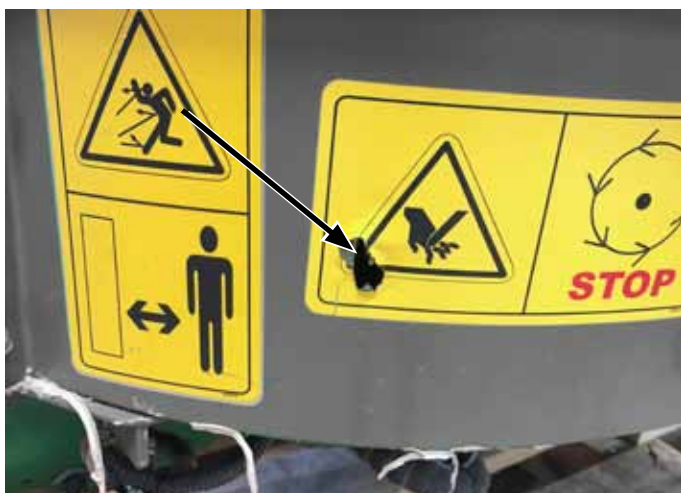
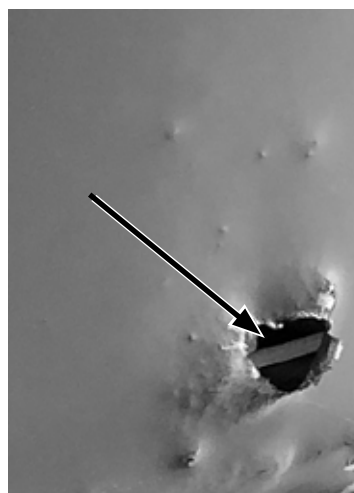
- Holes in surfaces

- Foreign objects have been processed through the system

Major Failure

- Adjust the height of the ground pressure on header so as not to pick up foreign objects from the ground
- Avoid use in fields with many rocks. Decide if crop on ground is worth processing through the SCU, know that rocks will create damage. Ensure ground has been rolled after seeding
- Replace panels as required

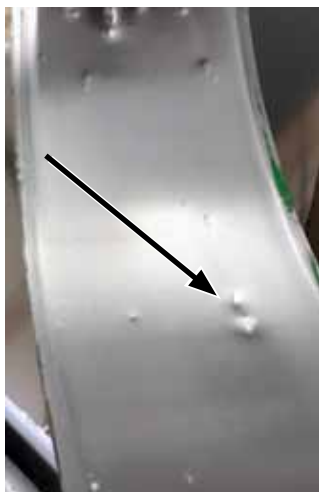
Minor Wear

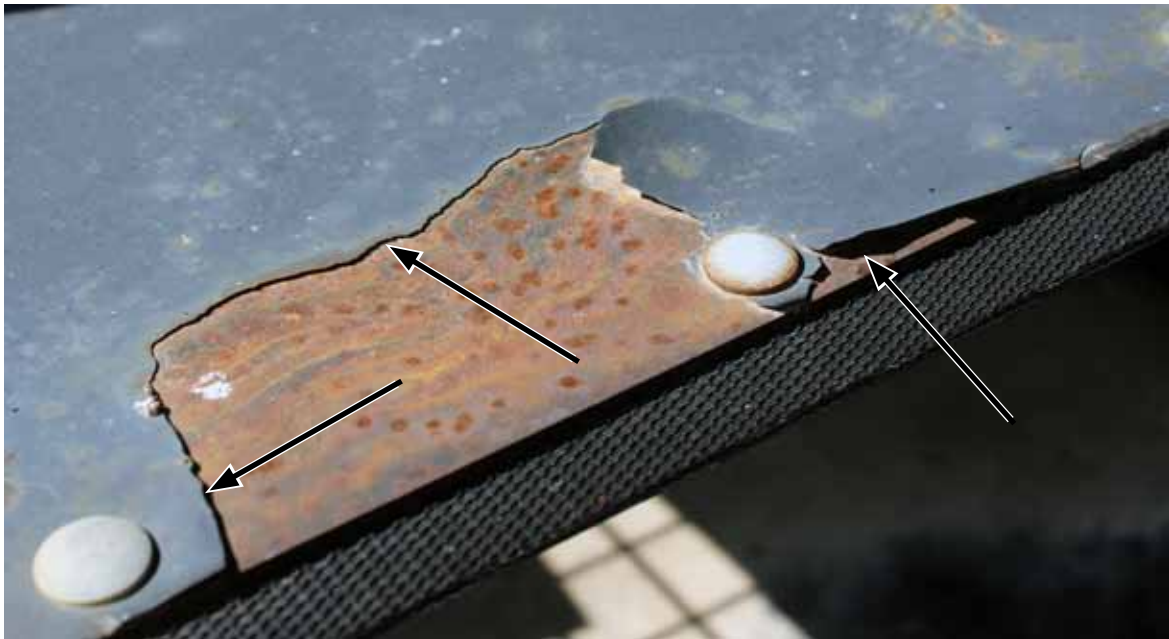
- Painted surfaces are flaking

- Manufacturing defect
- Corrosion due to wet residue left on machine during off season

Major Failure

- Contact customer service with pictures. Parts may be required for further analysis

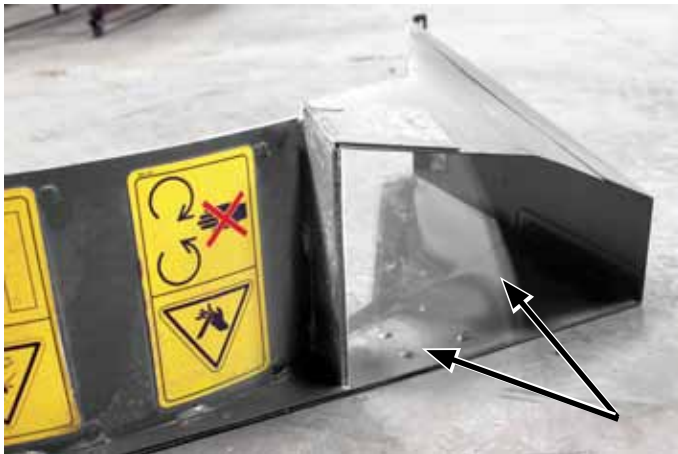
- Paint on the inside of the discharge outlets has worn off

- Product processed through the SCU is discharged through this opening at a high speed and will wear the paint off

Minor Wear

- Touchup with spray paint if desired

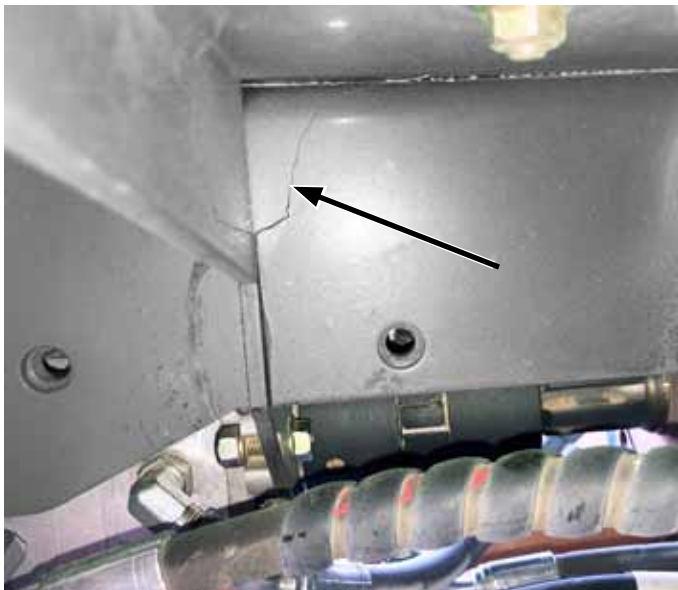
- Frame has cracked or bent

- Hit foreign object - did not raise SCU for transport
- Driving speed is excessive for terrain
- Driving through gulleys, ditches and holes

- Always move SCU to rear/highest position for transport
- Drive slowly on rough terrain
- Avoid gulleys, ditches and holes

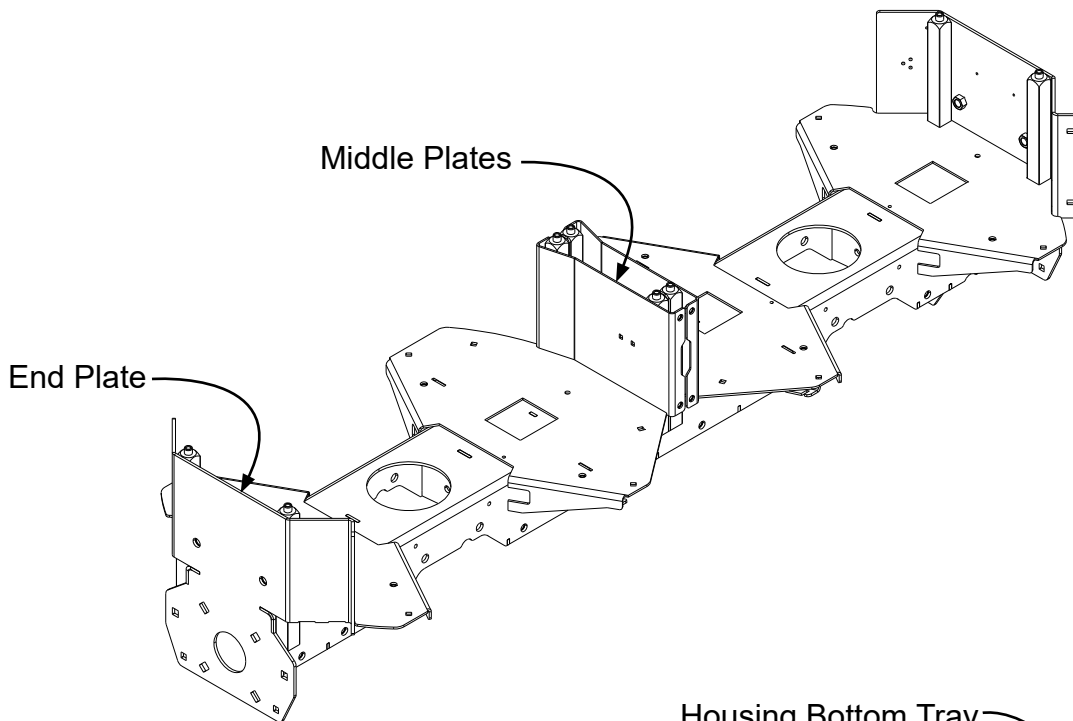
- End plate or middle plate of frame is worn

- Clean out covers or housing bottom trays have worn through and were not replaced in time

Middle Plates      Clean out Cover

- Repair is possible, spot weld only / ensure any welding does not warp frame
- Replace frame if required

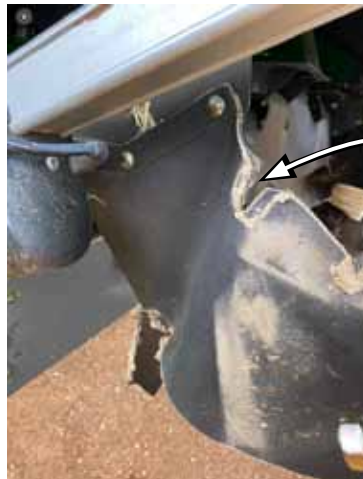
- Holes in sieve extension bottom rubber belting

Major Wear

- Inspect on a regular basis, if holes appear on the bottom or sides of sieve extension bottom rubber belting, replace accordingly
